NPIC/R-1259/64 June 1964

PHOTOGRAPHIC INTERPRETATION REPORT

BOMB DAMAGE ASSESSMENT PHONG SAVAN AIRFIELD AND AAA SITE, XIENG KHOUANG, LAOS

MISSION LUCKY DRAGON 25X1

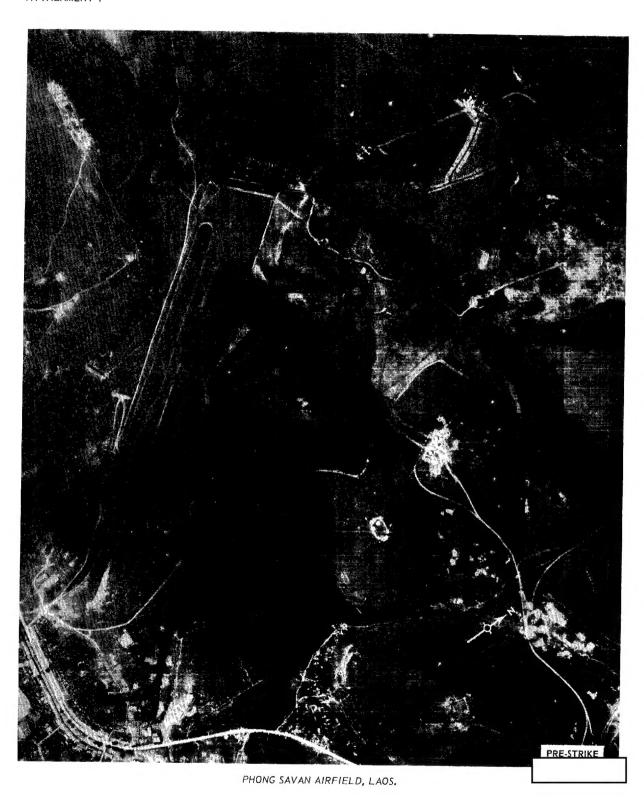
NPIC/R-1259/64 ATTACHMENT 1

Phong Savan airfield is situated 11 nm NW of Xieng Khouang, Plaine des Jarres area, 19-27N 103-13E. It consists of a 3,000 x 160 ft NW/SE serviceable sod runway. Facilities include four support buildings immediately west of the SE end of the runway. See attachment 1.

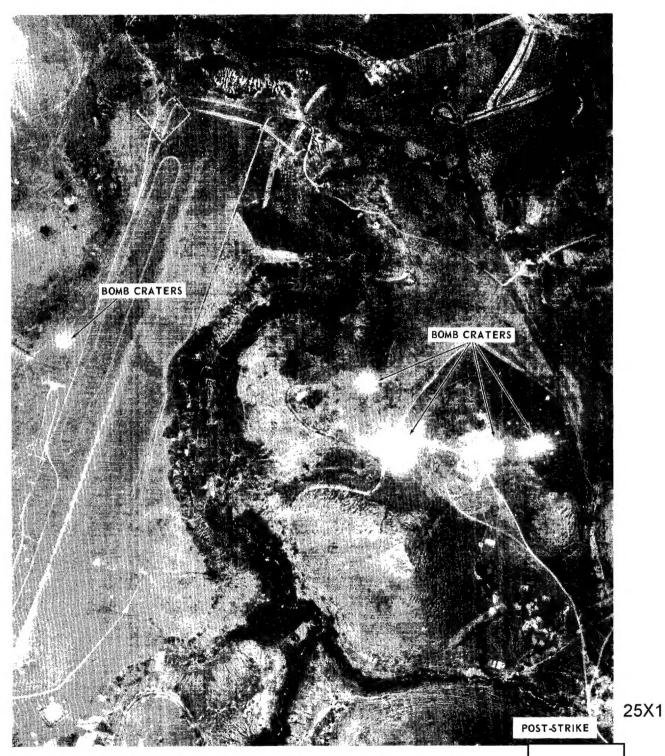
NPIC. R-1259/64 ATTACHMENT 2

Phong Savan airfield was attacked by four USAF F-100 aircraft on _______ The amount of expended ordnance is not known, however, ll bomb craters and two probable bomb craters are observed near the airfield. No direct hits were recorded on the airfield and it remains serviceable. All but two of the hits were recorded to the north, with one observed near the extreme edge of a strongpoint resulting in only superficial damage. The strongpoint appears to be occupied at the time of post-strike photography, with at least two occupied automatic weapons positions and numerous trenches and firing bays observed throughout the area. The two previously reported occupied 37 mm AAA positions now appear unoccupied. No strike photography is available for determination of occupancy at the time of the strike. See attachment 2.

The craters observed at Phong Savan airfield are tabulated as follows:

PHONG SAVAN AIRFIELD, LAOS.

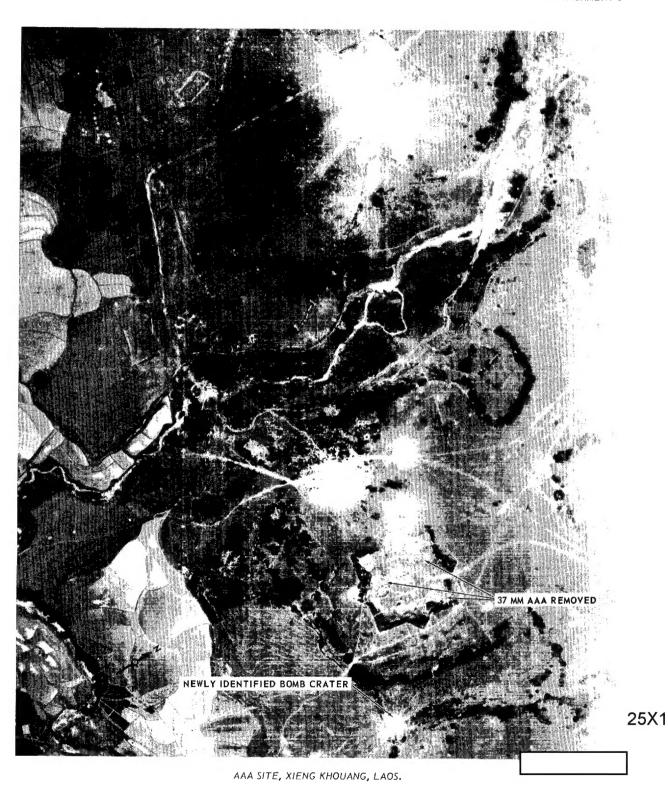
NPIC/R-1259/64 ATTACHMENT 3

NPIC/R-1253/64, "Bomb Damage Assessment, AAA Site, Xieng Khouang, Laos," based on Mission reported nine bomb craters on and west of the site, and one possible dud impact crater also west of the site. A review of LUCKY DRAGON a re-evaluation of Mission reveal a tenth bomb crater approximately 300 ft east of the SE corner of the site. The site now appears to be unoccupied. The two trucks reported within the site have been removed. No activity is observed within the area. See attachment 3.	25X1 25X1 25X1
•	25X1
